## Rainfall and Landslide Susceptibility in Hakha Environ in Northern Chin State, Myanmar

This research emphasizes the cause of landslides that occur in Hakha Town and its environ. The main aim is to investigate the distinct phenomena that result in a landslide and to provide suggestions that can reduce the risk of landslide in its prone area. Regarding the two phenomena, natural and man-made, the data on soil, steep slope, monsoon rainfall, pine forest areas, water sources, motor-car road area, population, and houses were collected by field survey, observation, and questionnaires. The collected data were processed and analyzed by using remote sensing methods, qualitative and quantitative methods, and Geographic Information System. According to the results, major causes of the landslides in the study area are found to be due to location lying between 1,830 meters (6,000 ft) and 2,440 meters (8,000 ft) above sea level and establishing of the settlements on steep slopes, receiving plenty of rainfall under the mountain climate with extremely cold winter season, the existence of unstable and unconsolidated soil and lithology, extending construction of new roads and expansion of the ex

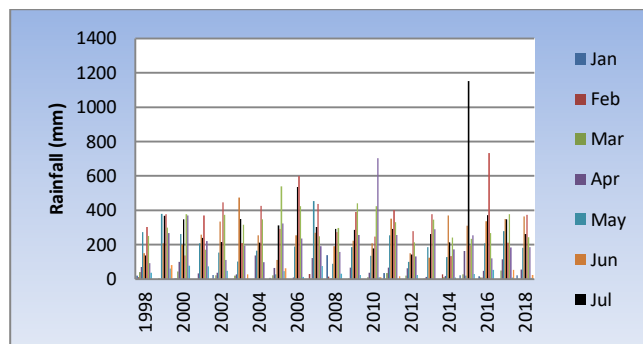
Fig. 4: Monthly Rainfall Distribution between 1998-2018 (Source: Based on Table 3).

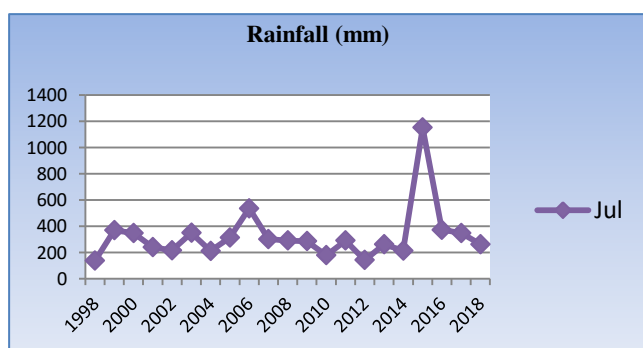
Fig. 5: July Rainfall in Hakha Area 1998-2018.

In fact, 780mm, rainfall received from 26<sup>th</sup> to 31<sup>st</sup> July 2015, represented 68 percent of July rainfall (1,151 mm) and exceeded average monthly rainfall (45.3mm) of July. Moreover, it was 32 percent of annual rainfall

(2,406mm) of Hakha. Such exceeding caused landslide in Hakha.

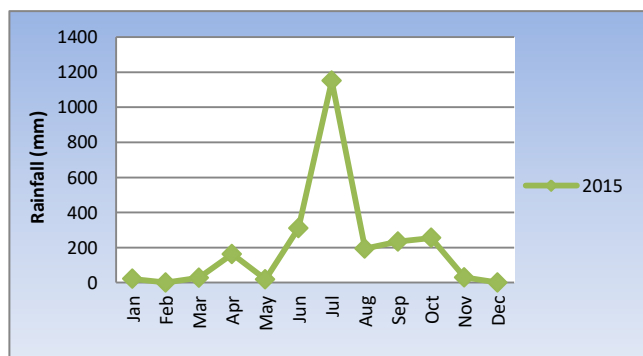
Fig. 6: Monthly Rainfall Distribution in Hakha Township in 2015.

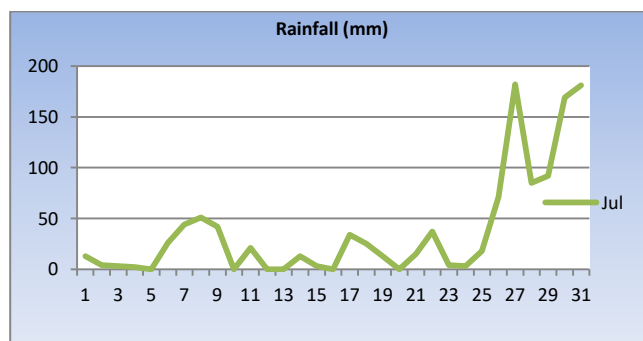
Fig. 7: Daily Rainfall in Hakha Area in July 2015 (Source: Based on Table 2).

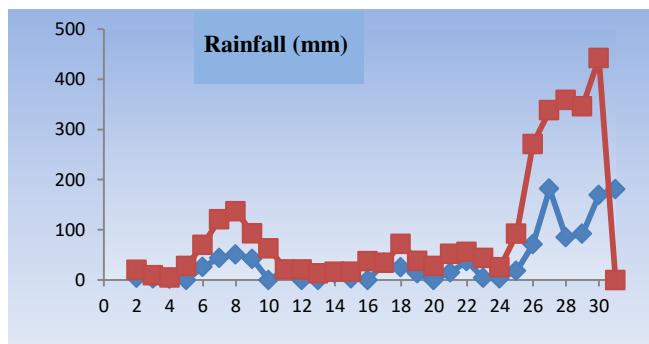
**Fig. 8:** 3- day running means for daily rainfall at Hakha, July 1- 31 2015 (Source: Table 4).

The minimum thresholds for each combination of landslide triggering rainfall cumulative are shown by the green line which is used to demarcate the lower bound precipitation below which no slope failure initiates. These thresholds are identified visually, on the scatter plots between the daily rainfall and the cumulative antecedent rain. The relationship between the landslide occurrences with the daily and the 3 days prior rainfall is defined by running mean (Maung Maung Aye, 1988; Gregory, 1980). Therefore, this is shown to represent a difference between sample means that have occurred by chance with a probability of greater than 10 %. Thus in this case the apparent fluctuation involving change in 3,5,7,9 and 15 day means of the order of nearly (272 mm) can be accepted as statistically valid, and further evidence must be sought before such (a fluctuation will be accepted as a reasonable possibility (Wallace, 1895).

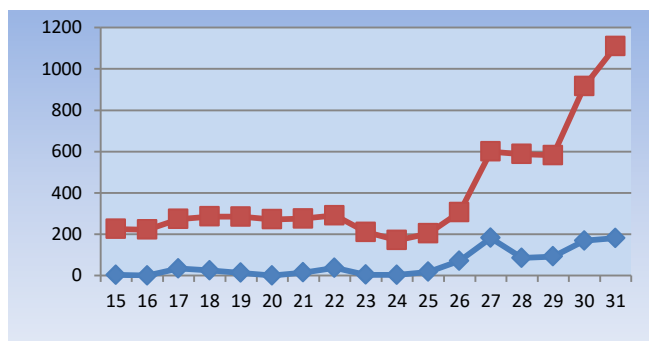
**Fig. 9:** 7- day running means for daily rainfall at Hakha, July 1- 31 2015 (Source: Table 4).

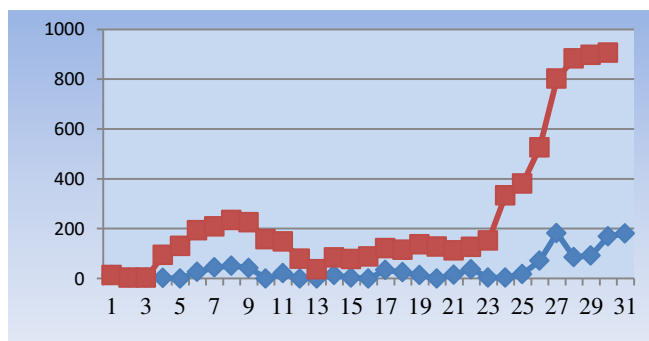
**Fig. 10:** 9- day running means for monthly rainfall at Hakha, July 1- 31 2015 (Source: Table 4).

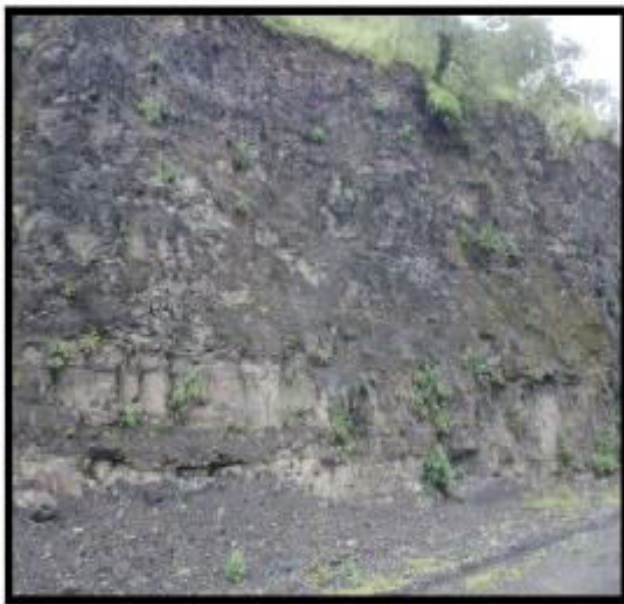
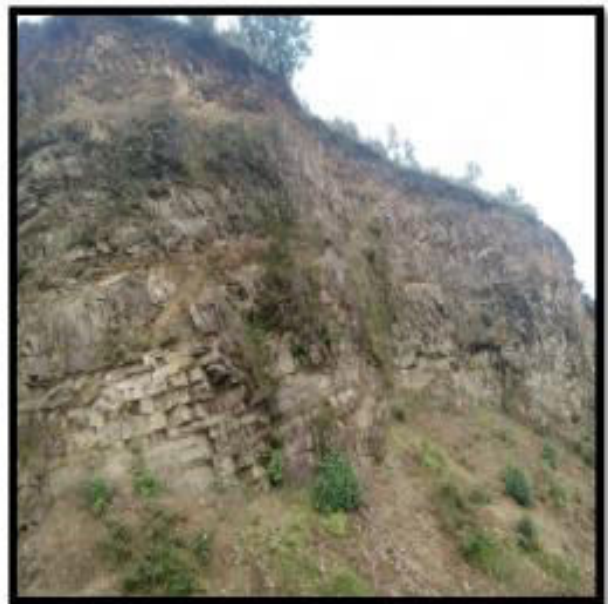
**Photo 1:** Thin to Medium bedded Sandstone at Rhung Taung Long 93 36 56 E and Lat 22 38 25, UTM 2293.10.

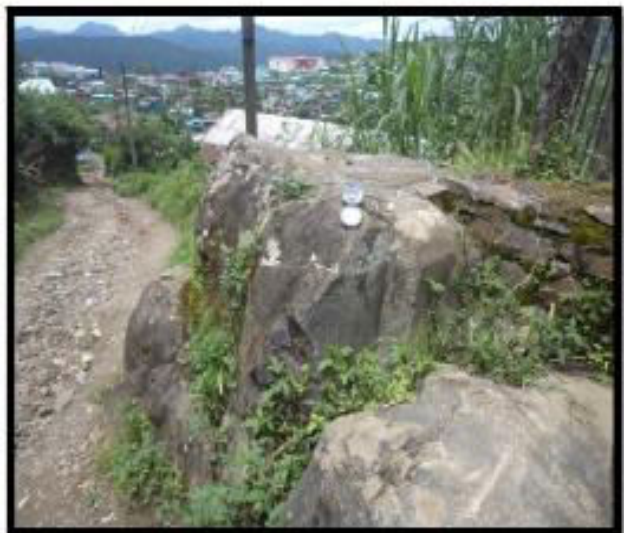
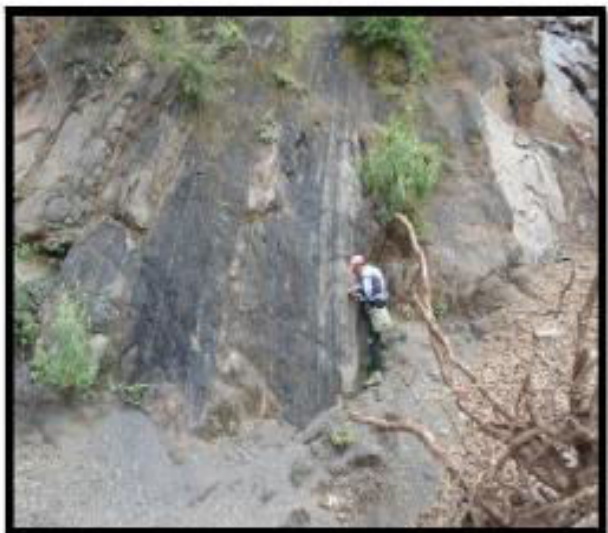
**Photo 2:** Light Grey Colour Limestone near Ring Road of Hakha Town.

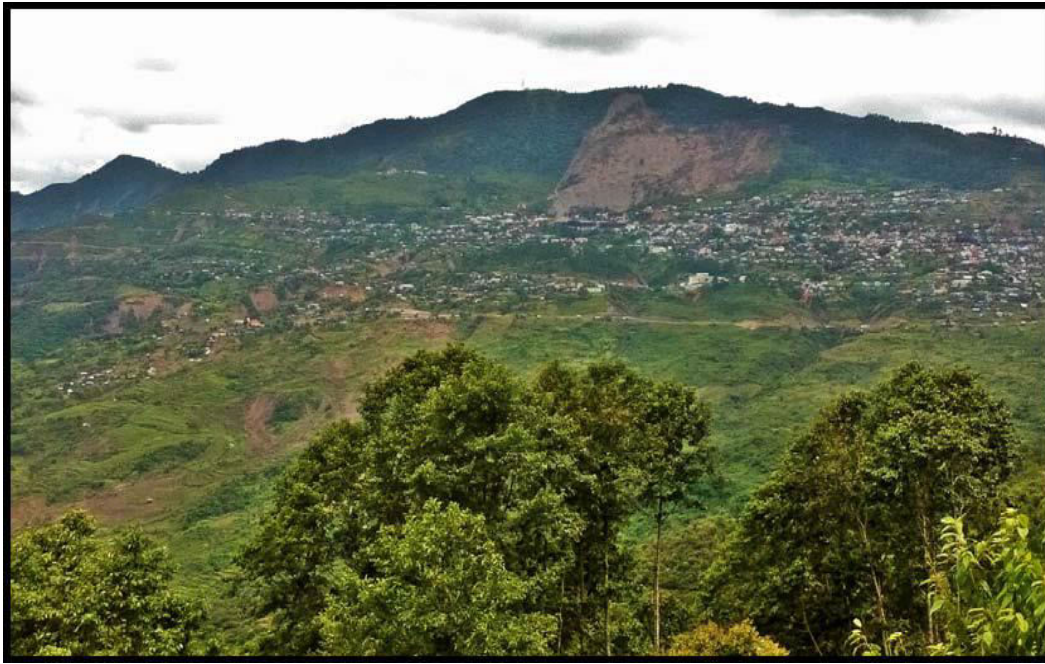
**Photo 3:** Landslide Effects at Rhung Taung in Hakha Area.
